Fifteen-Year Exposure Test of Porcelain Enamels

Dwight G. Moore and William N. Harrison

Building Materials and Structures Report 148

Issued June 28, 1957

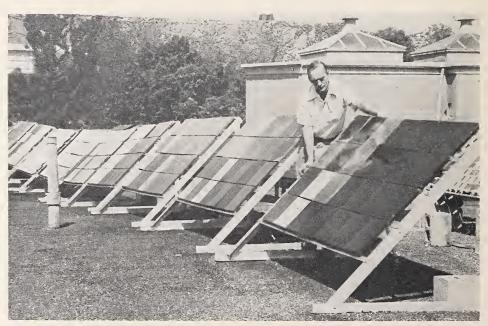
Figure 2. Exposure-test installation on the roof of the Industrial Building at the National Bureau of Standards.

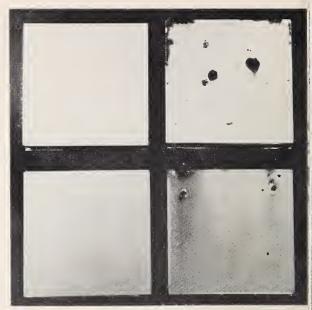
Figure 3. Four panels after 15 years of exposure at Atlantic City.

All of the panels were inspected for evidence of corrosion. Where the initial coverage was complete on all parts of the panel no corrosion was noted, irrespective of the type of enamel applied. However, on many panels the under side was protected with only a single groundcoat application, and good coverage of the metal was not always achieved. Corrosion started at these areas of poor coverage, and spalling of the enamel on the face side occurred after the corrosion had progressed only part way through the thickness of steel.

Hydrogen originating from the action of condensed moisture on the unprotected steel is believed responsible for the spalling. Norton [5] has shown by a tracer technique that the hydrogen generated from such a reaction will permeate the steel structure at room temperature, and numerous investigators, including Zappfe and Sims [6], have demonstrated that whenever hydrogen diffuses through steel, sufficient pressure can be generated to rupture the enamel on the opposite face. Thus, it appears entirely reasonable that the observed spalling behavior could be caused by hydrogen diffusion.

The surface spalls, which resembled large fishscales, were noted on only a few of the panels at Atlantic City at the 7-yr inspection. However, after 15-yr, the majority of the panels at that location showed one or more of these surface spalls.

Figure 3 is a comparison of panels having good coverage on the under side (two or more enamel applications) with similar panels that had poor coverage (a single ground coat with local breaks in the coating). All four of these panels were from the Atlantic City site, where corrosion on the unprotected metal was especially severe because of the "salt-air" conditions. Fortunately, the center area of the panels was free of spalls in almost all cases, and therefore they did not interfere with the gloss and color measurements.

Specimens on left had good enamel coverage, whereas the two on the right show holes in the panel caused by rusting through from areas of incomplete coverage on the back side.

- 1. When the enamel is applied to an iron or low-carbon-steel base, at least two coats of enamel should be applied to the back surface so as to insure good coverage of the metal and prevent damage from corrosion. Good coverage on the face side is an obvious requirement.

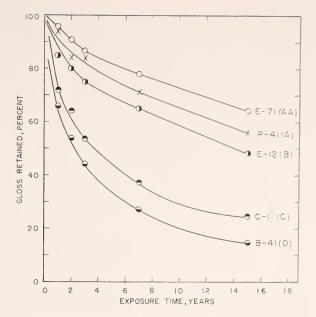
Figure 4. Selected data showing change in gloss with exposure time for five panels at the Washington, D. C., site.

In general it was noted that the specular gloss changed at a faster rate in the earlier stages of exposure than later. Figure 4 illustrates this effect for five panels at Washington, D. C., whose surfaces had been washed with trisodium phosphate solution. These same panels, along with all others from Washington, were later cleaned by scouring so as to conform to the cleaning procedure used at the other three locations. The effect of the scouring treatment in raising the percentage of gloss retained by the five panels is shown by the following tabulation:

Letters following panel numbers indicate acid-resistance ratings by citric acid spot test.

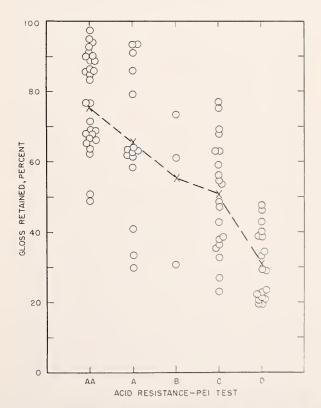
Figure 5. Percentage of gloss retained for ename's of fivelasses of acid resistance after exposure for 15 years it Lakeland, Fla.

Dashed line is drawn through average value for each class of accel resist. Accel
